BLUFF MILITARY BASE STORMWATER DISPOSAL: CONSTRUCTION OF A SHAFT WITH AN INCLINED TUNNEL OUTLET TO THE BEACH

Mark Richter, Shakira Sattar, Vinesh Sookan

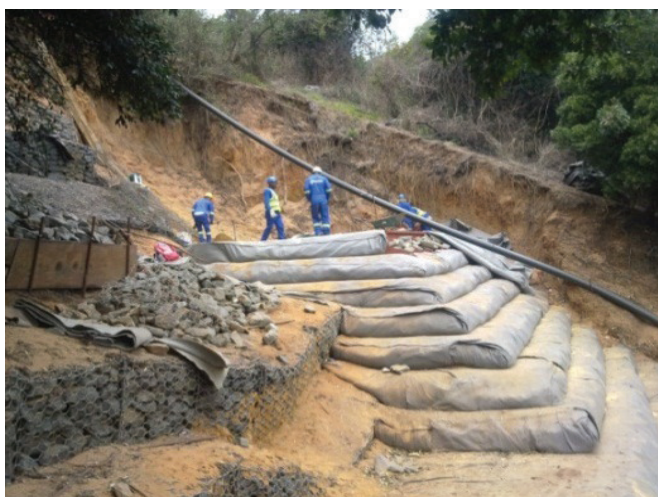
FIGURE 3 Reinstatement of slope using geofabric steps

The repair of the erosion gully comprised the use of a soil reinforcement technique consisting of geofabric steps. The steps were constructed using a wrap-around 'geostep' design, involving steps constructed by the use of insitu soils folded or wrapped back into the slope using a geotextile, and then covered with soil and vegetated. The steps tied into the natural slope angle which ranged between 33° and 38° in order to allow for reinstatement of the original slope. Removable metal forms were used to construct the steps uniformly and to ensure the correct slope angle was obtained. Access on the slope was fairly difficult and importation of soil from the shaft/tunnel part of the site to reinstate the eroded slope required the use of a hopper and chute system to deliver soil to the area of step construction.

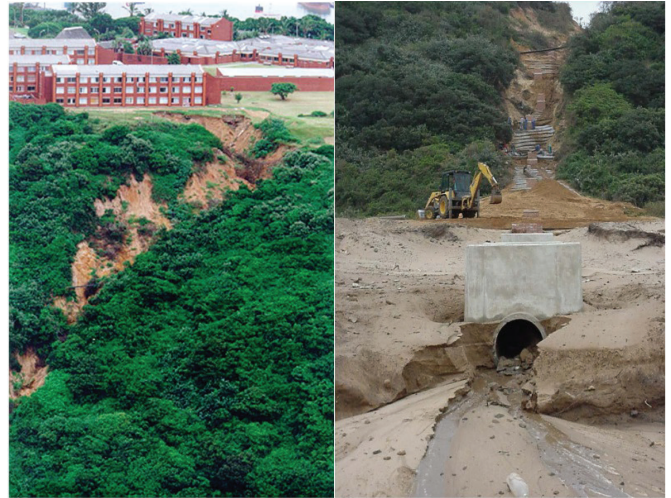
FIGURE 5 (left) Erosion gulley below Block E (2007)
FIGURE 6 (right) Reinstatement of slope

annual expenditure in repairs and maintenance. Major structures at both the top and the bottom of the slopes have been threatened or damaged by the erosion gulleys and related slips. In 2001 poorly managed stormwater within the military base Block E experienced a dramatic loss of soil adjacent to the seaward facing side of the building, caused by a leaking stormwater service over a period of about 6 days (Figure 5). There was thus an obvious need to manage stormwater to prevent large scale erosion.

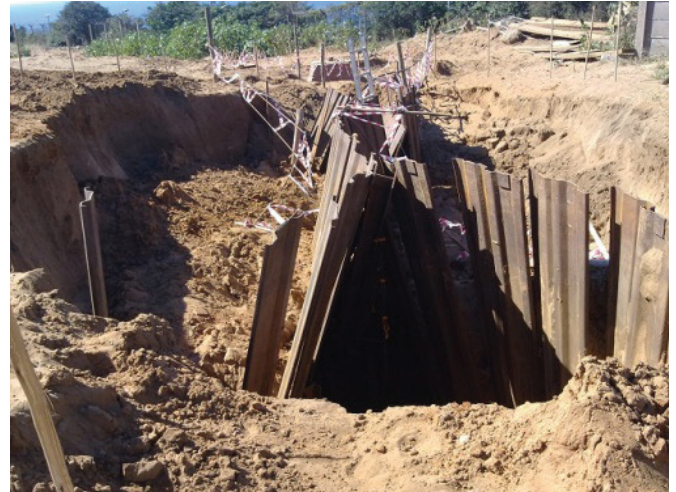
- non-cohesive sand, generally of very loose and loose consistency requiring lateral support since there were space constraints preventing battered excavations
- shored trenches were generally required, with one section of trench some 4 metres deep experiencing serious collapse
- many unknown services, some very old, caused significant delays to the trenching operation.

FIGURE 13 Collapse of poorly supported trench

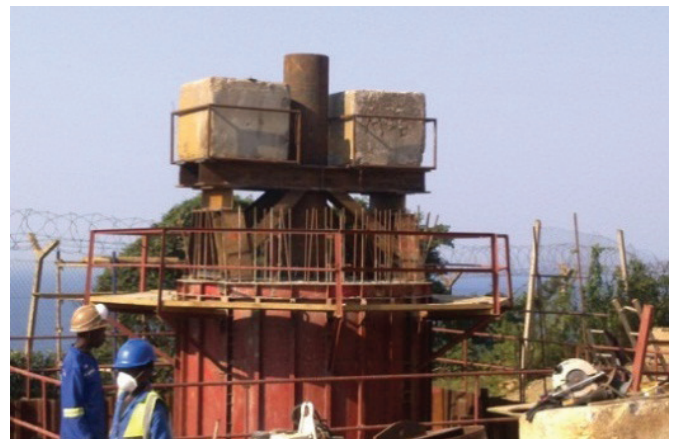
FIGURE 14 Dynamic loading on caisson

The shaft comprised a slip-formed caisson. The first two pours were required to provide a cutting edge for the caisson which with successive poured sections, sink of its own weight. Due to hard calcareous bands encountered at shallower depths than indicated from the drilling results, the caisson had to be assisted in sinking by applying kentledge and dynamic loading.

Shaft sinking was impeded by sandstone bands and concretions from as shallow as 16 m below ground level. These sandstone lenses were not identified in the borehole cores until about 62 m depth. It was confirmed that the grinding action of the core-barrel pulverised the weak sandstone and the arisings from the borehole resembled dune soils, confirming that there is thus no easy method to identify sandstone layers/concretions from normal drilling methods. The Contractor had to use water jetting methods and dynamic loading as well as applying Kentledge to break through these unexpected layers.

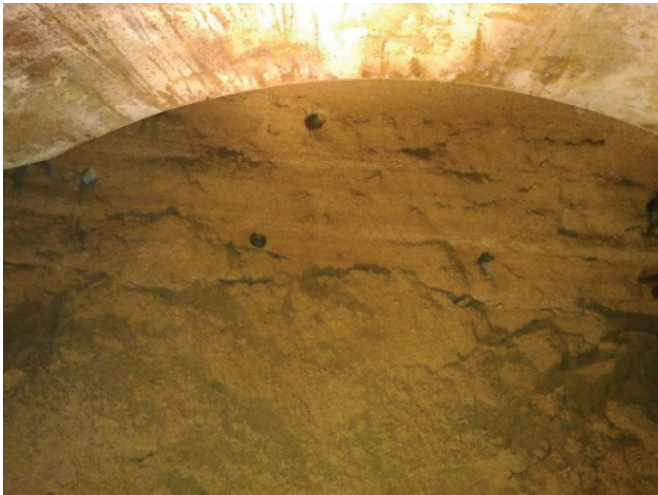
FIGURE 16 Calcarenite bands encountered in pipejack

The horizontal tunnel was advanced from the beach towards the shaft by using pipejacking methods. Due to the considerable length of the tunnel and the build-up of friction forces between the tunnel shell and the in-situ dune soils, frequently exacerbated by the hard calcareous sandstone or calcarenite bands or lenses encountered, inter-jack stations were required every 7 pipe lengths (17.5 m). Typical jacking pressures were of the order of 25 kPa, but increased to 30 kPa when calcarenite lenses of bands were encountered. Friction forces were reduced by injecting bentonite into the pipe-soil annulus void to lubricate the pipe and reduce jacking pressures.

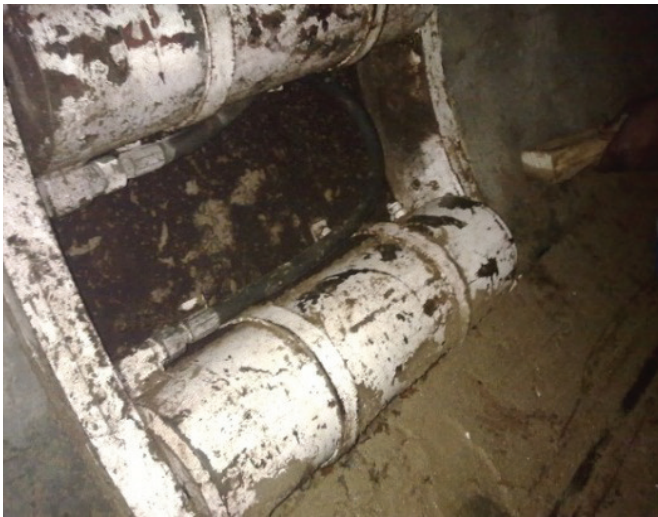
FIGURE 17 Interjack station to relieve sleeve friction

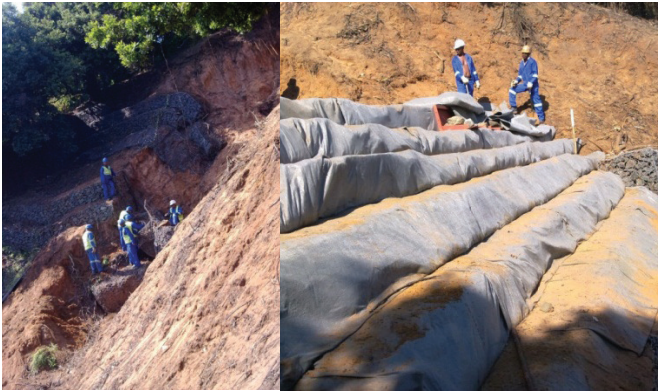
FIGURE 19 (left) Washaway repair. Note old gabions installed after earlier event

FIGURE 20 (right) Reinstatement of slope using geofabric steps
