REFURBISHMENT OF LARGE DIAMETER PRE-STRESSED CONCRETE PIPELINES (PCP): B7 PIPELINE, A CASE IN POINT

Khathutshelo Godfrey Maumela Pr. Cert. Eng.⁽¹⁾; Kirk Canary⁽²⁾; Ms Nozibele Masondo⁽³⁾

⁽¹⁾Rand Water, Bulk Water Distribution, Executive Manager;
E-mail kgmaumela@randwater.co.za

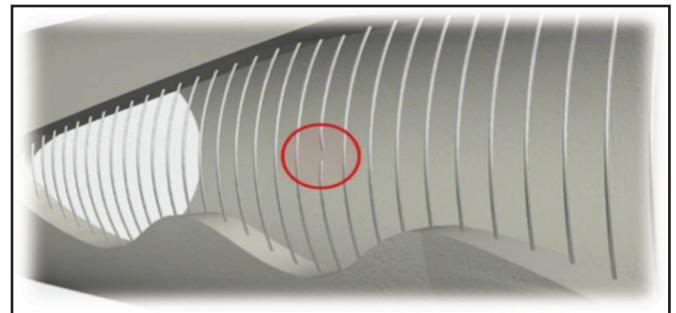
Figure 3: Schematic depicting wire break in PCP

The results indicated that in certain pipe sections, there were wire breaks ranging from 1 to 6 wire breaks. Due to the criticality of this pipeline it became necessary to only target the winter months for rehabilitation, as the demand is slightly lower during those months.

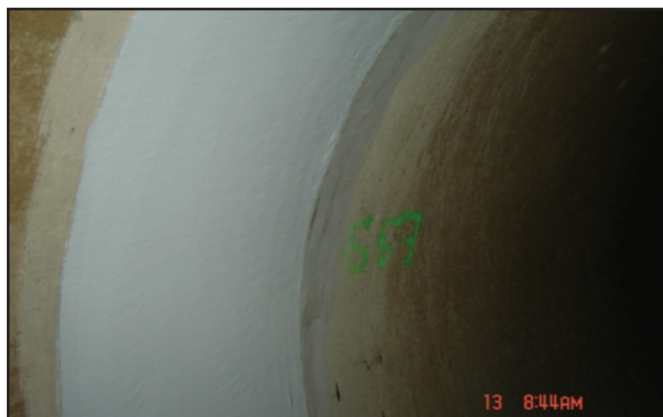
Figure 4: Carbon Fibre Repair

The carbon fibre product complies with all the requirements for use in the potable water industry. Safety standards from the oil industry and applied. Every repair comes with its specific material data sheet. All quality control procedures are documented and reported. Figure 4 below shows the completed carbon fibre repair in the pipe.

Depending on the pressures of the pipe, a carbon fibre design consisting of variable layers of specific fabric, specific resins and infusion methods are utilised. The repair is finished off with a flow coat, and the complete repair gives rise to a wholly protected defective pipe section returning the pipe to fit for purpose.

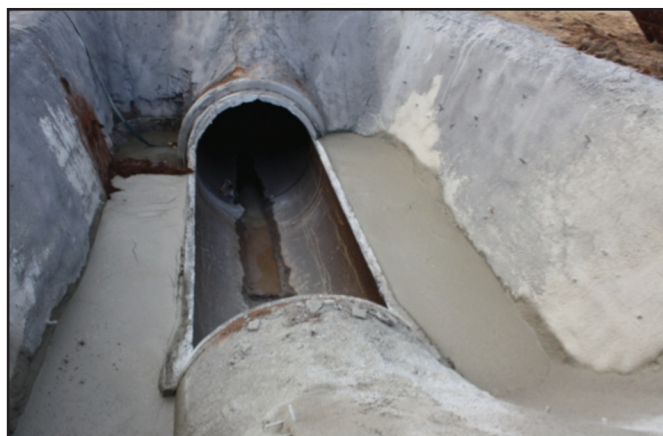
Figure 5: A typical Launch pit

The plan is to cut into the existing concrete pipe to create a launch pit through which the steel pipe sections will be inserted into the host pipe. (See Figure 5).

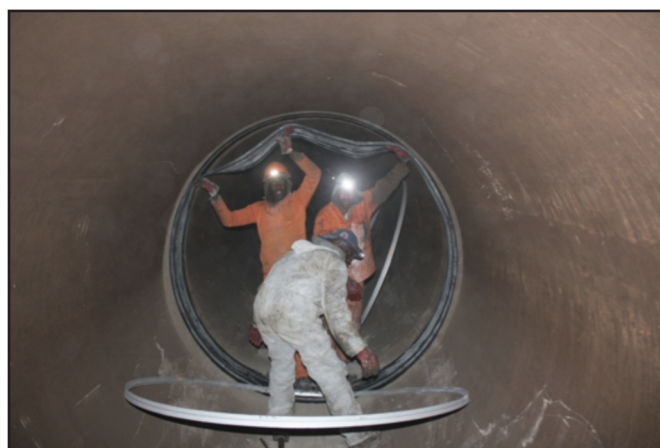
Figure 6: Installation of EPDM Rubber seal

- Wire brush joint area to remove loose surface material
- Apply an epoxy coating which is approved for the potable water industry (See figure 6)
- Install rubber seal with two stainless steel rings
- Jack to designed pressure – weld stainless steel straps into position
- Passivate welds to prevent oxidation.

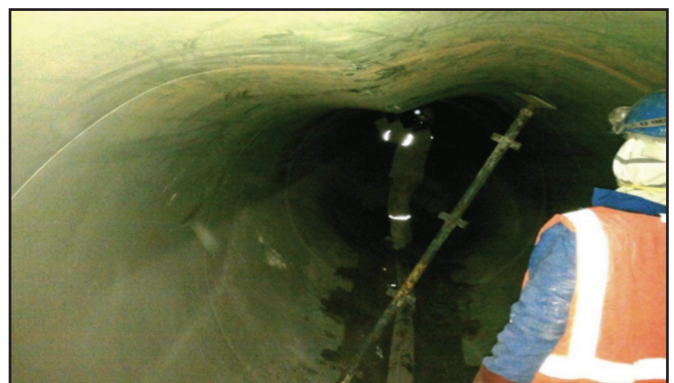
Figure 7: Buckling of slip-lined pipe

When pumping the grout, the pipes were not adequately propped, and the mix was pumped at a higher pressure, in an effort to fill the annulus. This resulted in buckling of sections of the steel pipe as can be seen in figure 7 below.

These sections were repaired by:

- Cutting out and removal of the buckled pipes
- chipping out the grout
- new sections of steel pipes were then launched to replace the damaged pipes
- adequate propping was employed

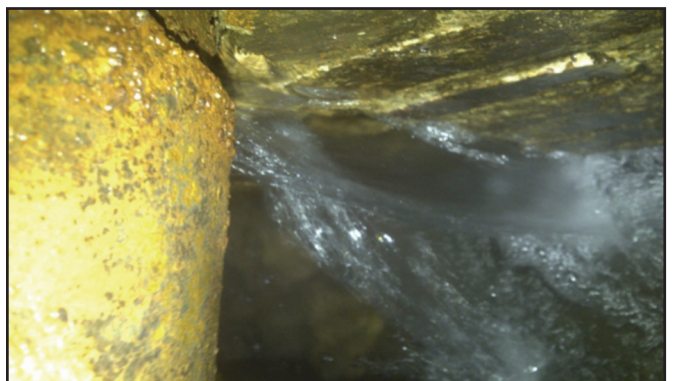
Figure 8: Leaking Scour Valve

The pipeline was charged with water on 10 August 2012, two weeks behind schedule. During the pipe charging process, leaks were detected at three different positions along the pipeline, i.e. Leaking area at Pit no. 1F, Pit 2 and leaking scour valve as shown in figure 8 below.

The pipeline had to be drained so as to allow repairs to be conducted on the leaking areas. The welds were dye panned and showed no anomalies, and mass concrete was placed around leaking joints. New

adapter flanges were also installed. The work was successful, but upon commissioning of the pipeline leaks resurfaced. The Pipeline Asset Manager then requested for a non-destructive leak detection and CCTV survey to be conducted along the sections of the leaks. The acoustic leak detection and CCTV survey method posed to be the best way of assessing the pipe as it reduces the impact of the day to day operation of the system, as well as loss of revenue and risk associated with draining and subsequently refilling the pipeline. The method is able to pinpoint the location of the leaks, while at the same time inspecting the internal condition of the pipeline using a combined acoustic hydrophone with integrated CCTV camera. This system uses the Sahara insertion platform and is capable of being inserted into live pipelines.

The results from the leak detection and CCTV survey showed no anomalies. The pipeline was then left in operation. Further assessments and repairs will be conducted when the next shutdown is offered during off peak season. The contractor was requested to do some external repairs on the three leaking areas. The leaks have since subsided.
