THE STRUCTURAL REHABILITATION OF THE FISH WATER FLATS WASTEWATER TREATMENT WORKS IN NELSON MANDELA BAY MUNICIPALITY

Venancio Andrade da Silva¹ and Ignatius Du Preez van Renen¹

¹Afri-Coast Engineers, Port Elizabeth, Republic of South Africa;
Tel: +2741 5058000; Fax: +2741 5853437;
e-mail: venanceda@afriacoast.com

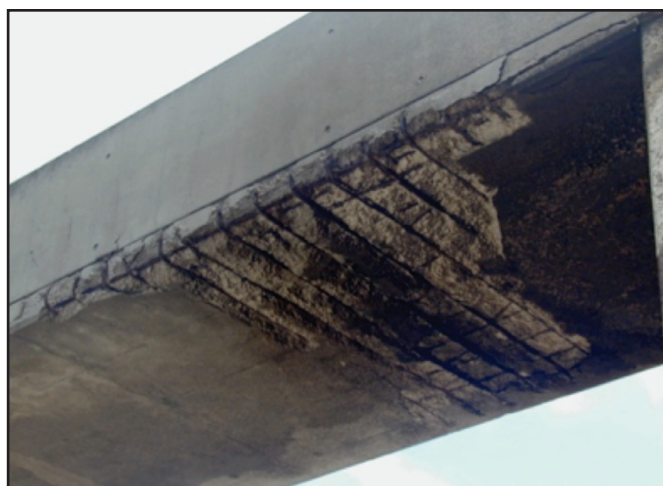
Concrete deterioration was noted to the aerator platform bridges in 1998 and the first extensive concrete rehabilitation works was undertaken simultaneously with the upgrade of the activated sludge reactors in 2002.

Figure 1: Typical severe concrete deterioration to an aerator platform recorded in 1998. Rehabilitation works to the structures were undertaken in 2001.

After the first structural assessment carried out in 1998, a rehabilitation contract was awarded by the Municipality in 2002 to implement urgent repairs to the aerator platforms. The cost of these works was ZAR 7.0 million and the scope of work included:

- Extensive cutting and breaking out of spalled and contaminated concrete
- Spall repairs with proprietary repair mortars
- Local thickening of the support columns in the aeration zone offering additional protection
- Installation of sacrificial zinc anodes
- Cementitious protective coating to the concrete surface.

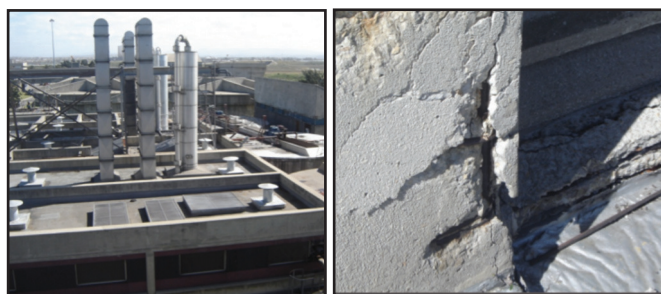
Figure 4: Illustration of corrosion damage to roof parapet walls to Heat Treatment Building (2009).

Figure 4 illustrates the extent to which corrosion of reinforcing, once it has been allowed to promulgate far enough, will cause concrete structural damage.

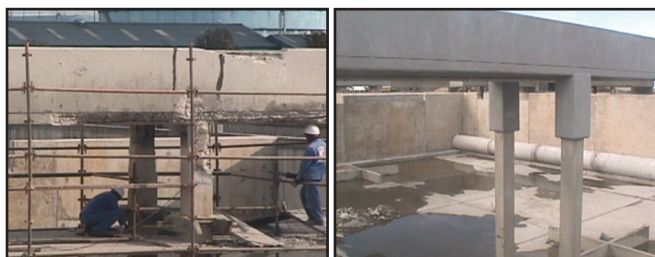
Figure 7: Left: Rehabilitation underway in 2002. Right: Completed rehabilitation.

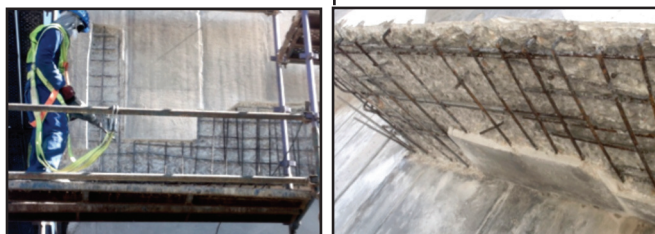
Figure 8: Cutting, breaking and preparing reinforcing steel for repair mortar application

- Surface Preparation (concrete surfaces) – high pressure water jet cleaning
- Spall Repairs – cutting and removal of delaminated reinforced concrete areas, preparing steel surfaces, application of repair mortars and crack injection chemicals,

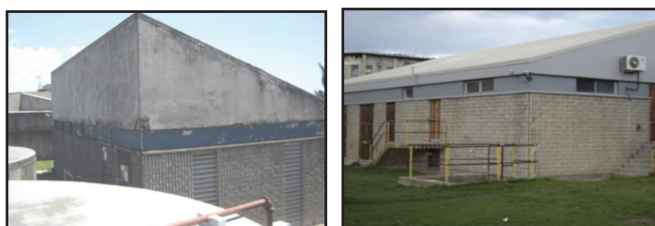
Figure 9: Substation No. 5 building before and after rehabilitation

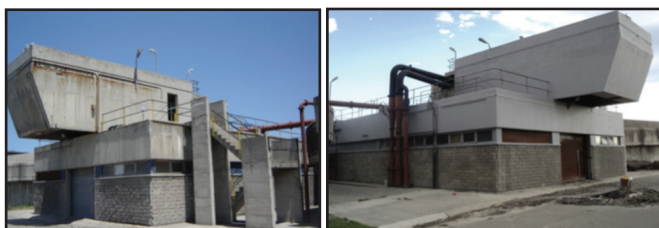
Figure 10: Thickener Pump House before and after rehabilitation

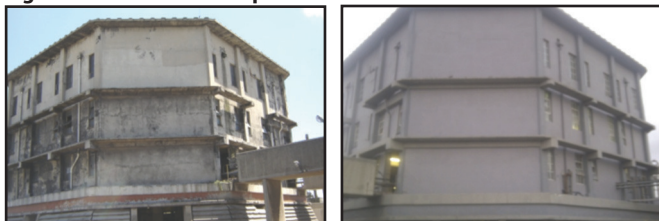
Figure 11: FS building before and after rehabilitation
