PAPER 17

FLOODING IN LADYSMITH, PROBLEMS AND SOLUTIONS.

Dr. Nezar A. Eldidy, Pr.Eng.
Sobek (PTY) Ltd

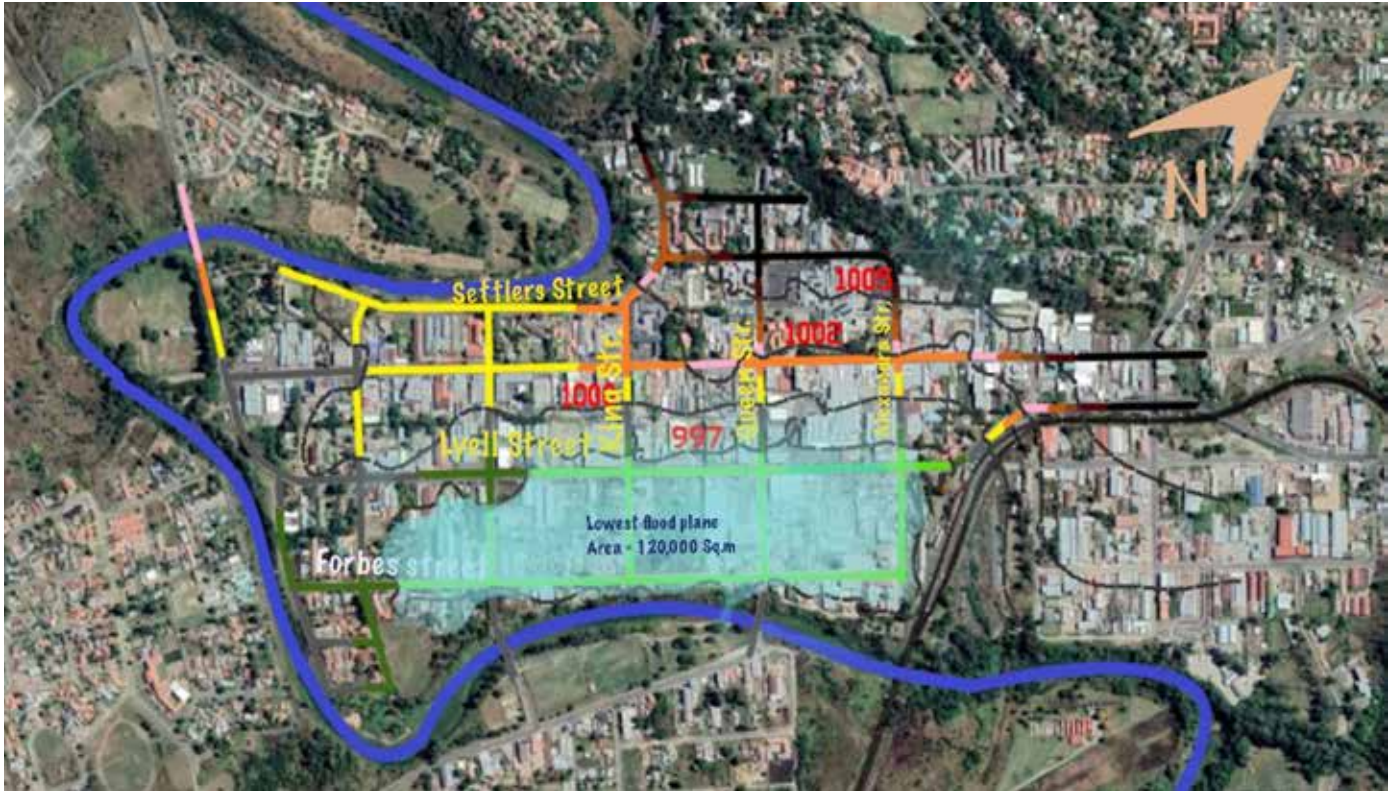
FIGURE 2: Topography of Ladysmith CBD and its flood plain – Basemap from Google

Ladysmith's CBD is like a cradle surrounded by the meanders of the Klip River from the left and the right at a higher level than most of it. The CBD is surrounded by elevated ground, with the lowest

ground cutting across from Princess Street to Alexander Street at a level of 997 amsl. (The area marked in blue in Figure 2 is the lowest area within the CBD).

734,000cu.m/hr (about 203 cu.m/sec), flowing towards the lowest point of the CBD, the flood will cover up to Lyell Street; putting Forbes Street under 3 m of water on average.

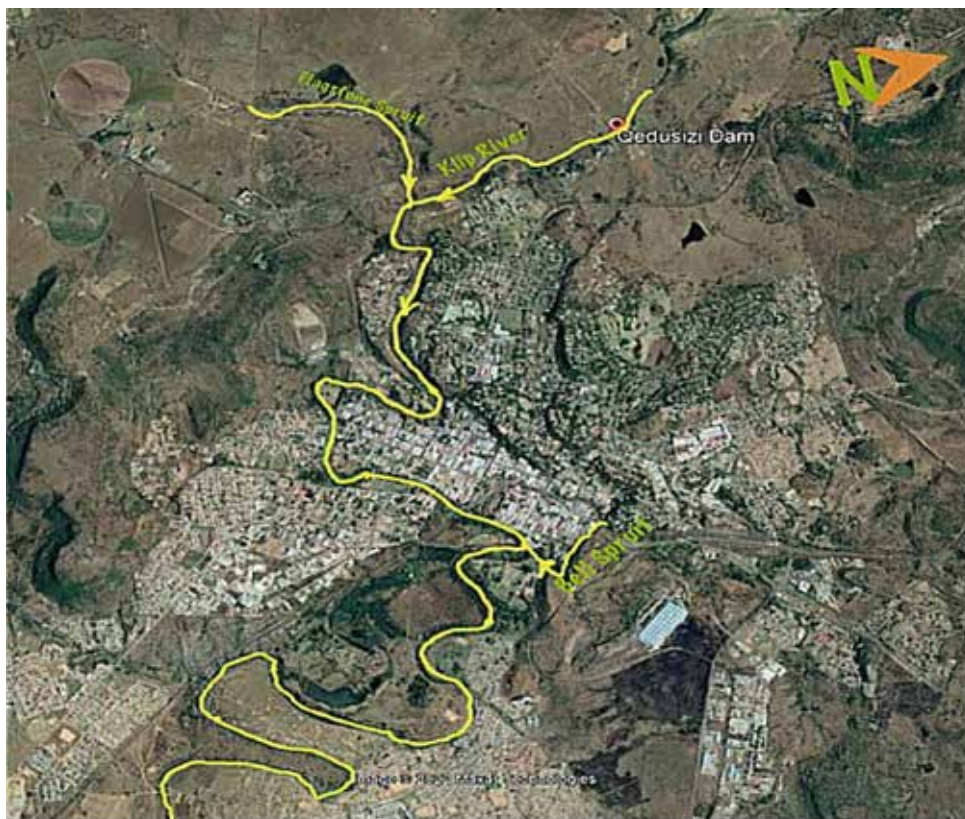
FIGURE 4: River System Upstream of Ladysmith CBD

Studying the cross-sectional capacity of the Klip River's meander; results show that the section's average carrying capacity has deteriorated to less than 50% of the maximum discharge from the Qedusizi dam and represents about 23% of the original carry capacity in some areas (section 3 of Figure 4).

Sections 1 to 3 are critical, and will overflow the banks, even during a 5-year flood cycle. These sections are on a higher land of the CBD, and flood water breaches the levees and overflows the banks towards the lowest point in the CBD.

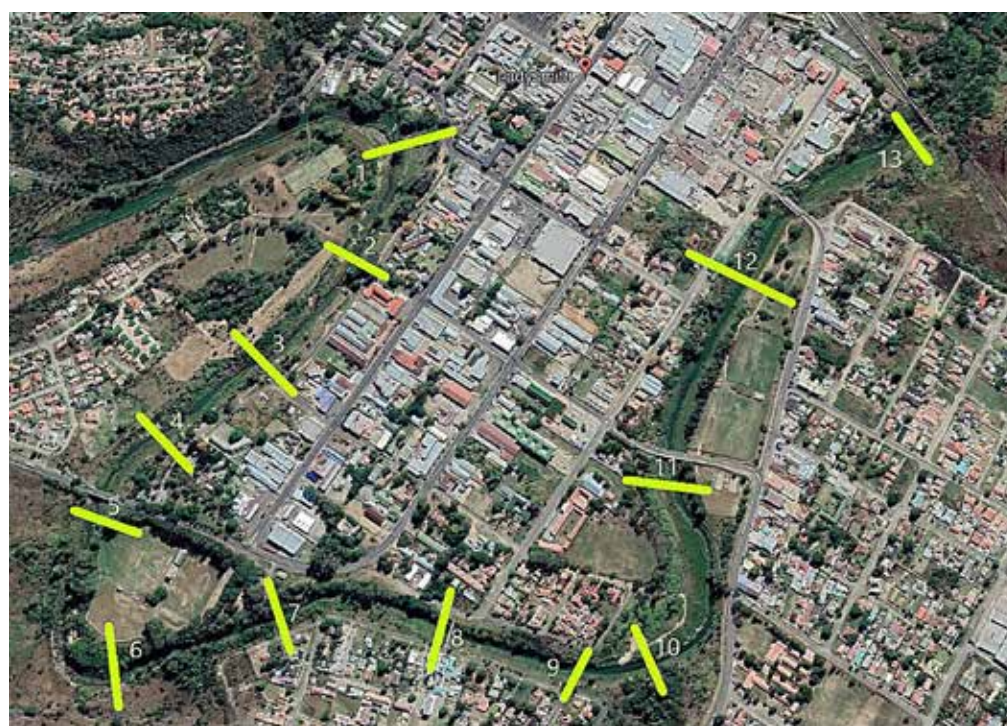
FIGURE 5: Key plan for section assessed along Klip River to be read with Table 1 – Basemap from Google

Based on the cross sections of the river in Table 1, the quantity of water overflowing the river's banks from sections 1 to 3 is to be about

- Dredging of about 1.0 million cu. m of silt and deposits from the river, to enlarge and deepen the cross-sections.
- Installing a pump station on Queen Street. The station hosts 3 pumps of about 1 cu.m/sec discharge and head not less than 10m.
- Building a discharge and calming lagoon with gabions and lined with

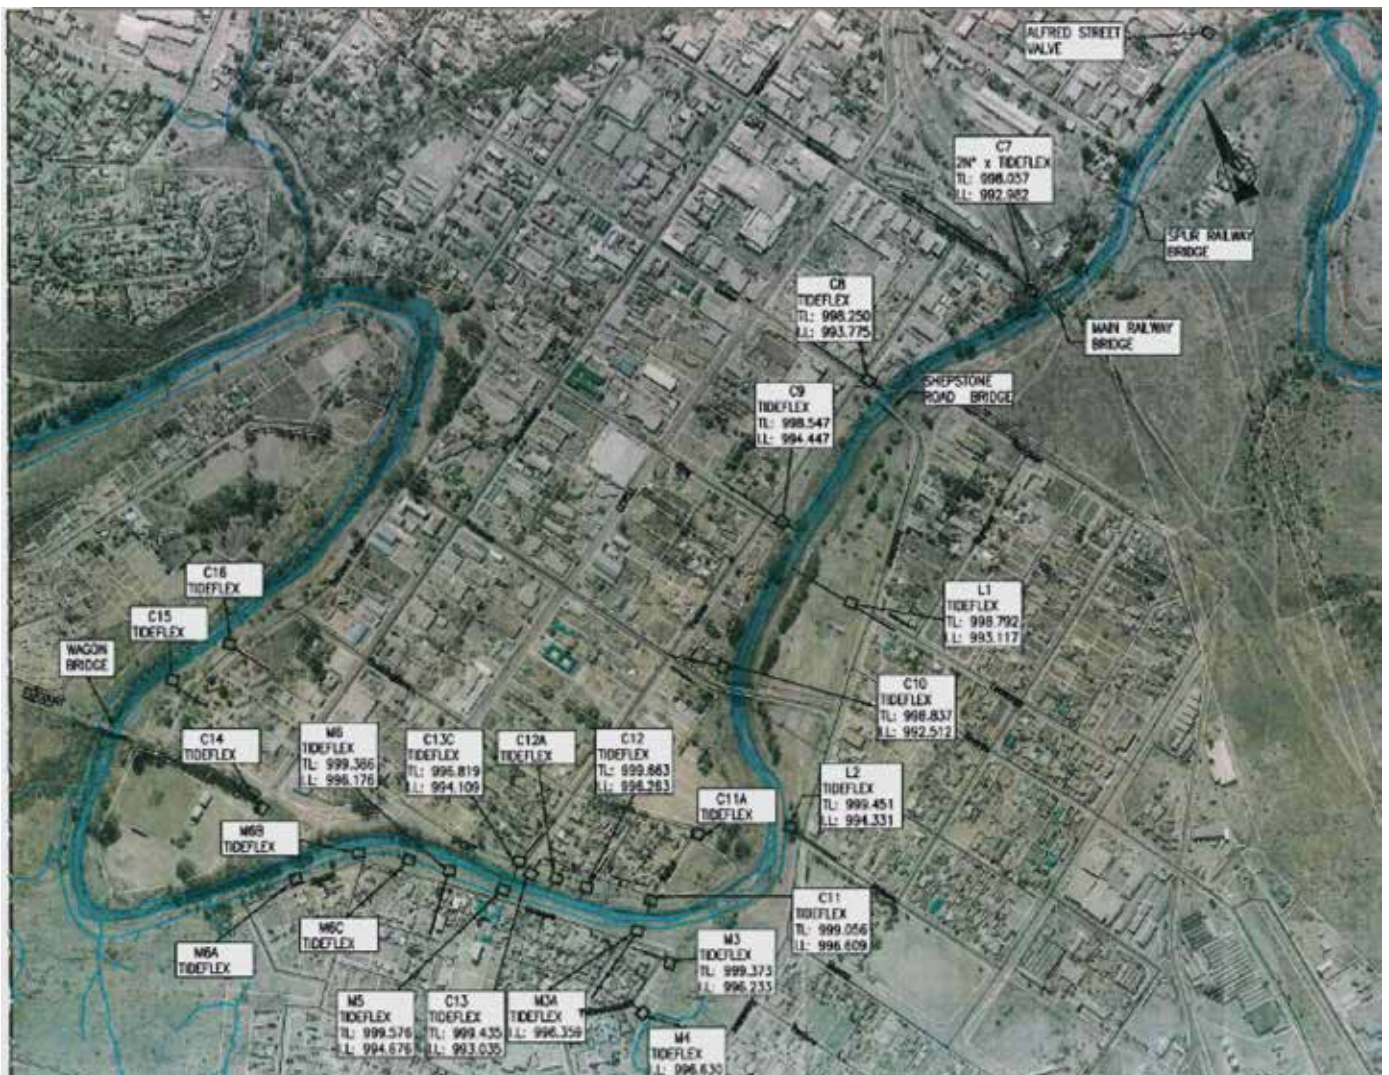
FIGURE 6: Drainage System through CBD – Courtesy Alfred Duma Municipality

The existing drainage pipes convey the storm water from the CBD into the Klip River through the 24 existing valve chambers (Figure 6).

The stormwater drains, pipes and existing structures are used to collect and carry stormwater away and release it into the river. The exiting stormwater system feeds the Klip River through the Duckbill Check valves.

In a post flood inspection, 11 out of 24 Check Valves were either damaged, or completely pulled out. Theoretically, such valves are non-return valves, but in practice, they come under passive pressure (water head from the receiving body) during flood and turbulence occurs at the outlet, which leads to damage of the valve.

996 and 992amsl, while the drainage pipes outfalls are located directly above the riverbed with diameters of 900mm to 1200mm. During a rain event the Duckbill valves will be opened to discharge water from the CBD drainage gravity line (Active Pressure), while from the river side (or the receiving body) the water will also be rising until it exceeds the top of the pipe or the upper tip of the already opened valve. When the water head in the river exceeds the level of Forbes Street (i.e., Passive Water Pressure from the river side exceeds the Active Pressure), water will flow back into the drainage system, and back to CBD. The backflow can reach 72,000cu.m/hr which can put the area marked in blue in Figure 2 (i.e., the lowest area in the CBD) under approximately 2m of water within 3.5 hours of reaching high water level in the river due to pressure difference.

- Replace Duckbell Valves with automated Sluice Gates or with Flap valves.
- Installing 1 x 900mm collector pipeline across, from Alexander to Princess Street, with concrete chambers. The pipe will be a higher level than current drains.
- Installing 2 x 600mm steel pipeline to evacuate water from pipe station to the discharge lagoon.
