THERMALLY FUSED PVC PIPE HELPS ACCELERATE ADOPTION OF TRENCHLESS PIPE INSTALLATION TECHNIQUES IN NORTH AMERICA

ABSTRACT

INTRODUCTION: 3,800 FOOT (1,140M) HDD BORE AND PULL-IN

INTRODUCTION: 37,000 FEET (11,100M) OF PIPE-BURSTING REHABILITATION

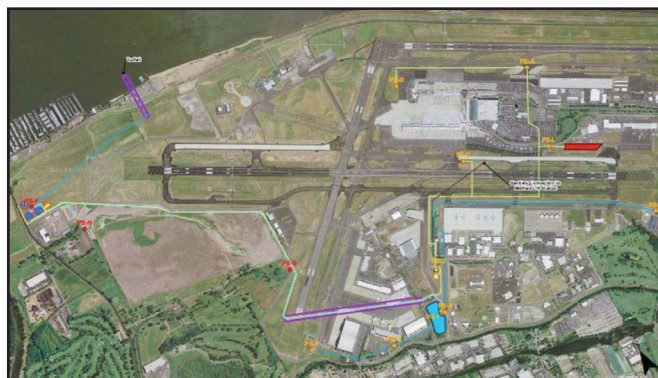
Figure 1 – Final site plan showing new treatment and conveyance facilities on the western side of the PDX property and the existing facilities in the central and eastern portion of the PDX property.

As shown in Figure 1 below, due to the significant restrictions placed upon construction activities at an airport, the enhanced system was located on the western edge of the airport property. However, the existing collection and management system is located in the central and eastern portions of the airport, representing significant design and construction obstacles in order to connect the two systems together.

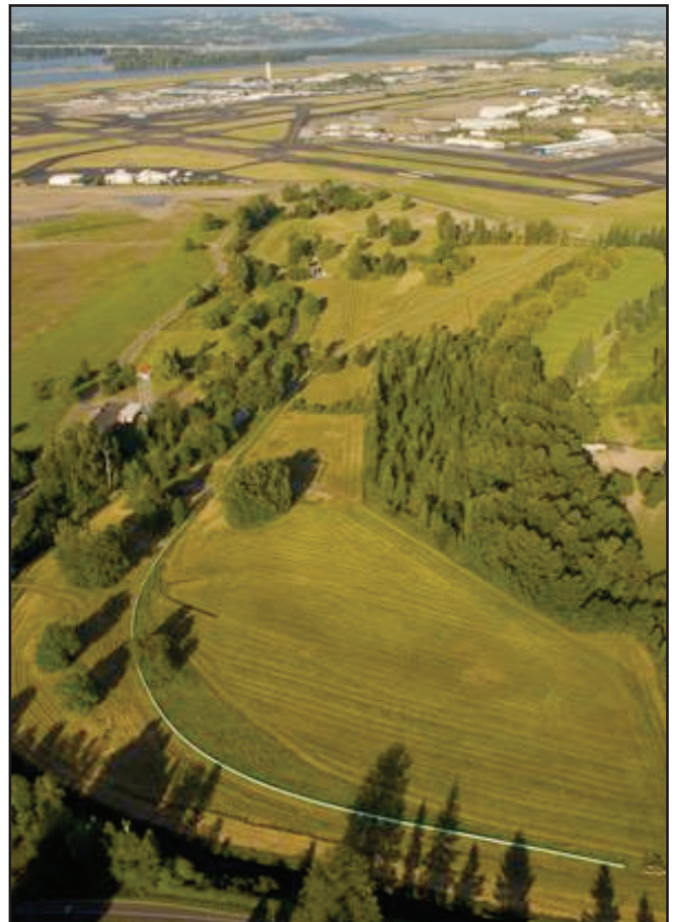
Figure 4. Lay-down area for the fused FPVCP sections

The required length of the bore, 3,800 LF (1,140m), was a significant length of pipe to fuse and stage – not only to string out in one length, but to make sure that it lined up with the crossing alignment. The fusion and lay-down area for the fused pipe (Figure 4) presented a major challenge because wetlands and environmentally sensitive areas that could not be disturbed existed in the work area that had to be used. JE Dunn, CDM, The Port of Portland, Kinnan, and UGSI ultimately identified an alternate alignment that did not disturb the wetlands, yet allowed for the full lengths for both 24" (600mm) and 6" (150mm) sections to be laid out.

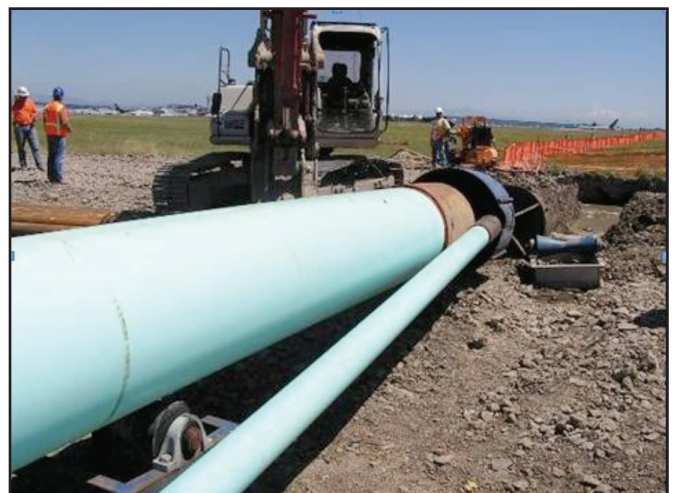
Figure 5. Start of Pull into the insertion pit

Kinnan custom-fabricated a manifold-style pullhead to separately link the 6 inch (150mm) and 24 inch (600mm) pipes and their individual pullheads simultaneously. Pullback commenced on July 27, 2010, with water ballast in the 24 inch (600mm) pipe to reduce frictional force in the bore. The pull was completed in 13 hours, exerting a maximum pull force of 117,000 pounds (520 kN). A successful pressure test was completed several weeks later.

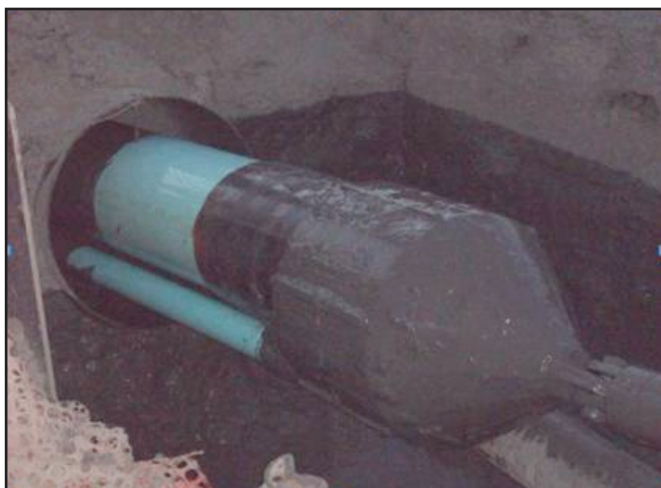
Figure 6. Pipe Bundle at Borehole Exit and Casing

The joint venture of Northwest Underwater Constructors (NUC) and Kinnan Engineering (Kinnan) was selected to perform the HDD for the airfield crossing. Underground Solutions, Inc. (UGSI) provided the FPVC pipe and fusion services for this crossing. During drilling, Kinnan encountered difficult and complicated drilling conditions. The same soils that precluded "jack and bore" methodology also had to be considered in the initial approach of the drill shot. Kinnan used a steel casing for the first ~120 feet (36m) of the installation to stabilize the bore.

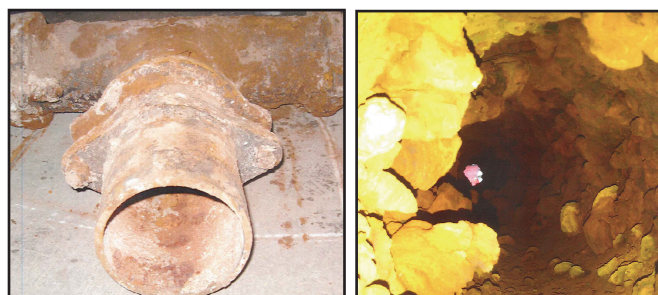
Figure 8. Typical water main in areas to be replaced, both outside and inside pipe showing tubercles.

Consolidated was facing the same aging infrastructure problem that many other utilities face, namely large sections of their system that needed to be replaced. These sections contained large amounts of undersized 4" (100mm) and 6" (150mm) cast iron pipe. The piping had served the system well over the years in these sections of the system, however due to large numbers of breaks, water quality issues and restricted flows in some areas due to tubercles and pipe size, it was becoming an ever-increasing concern.

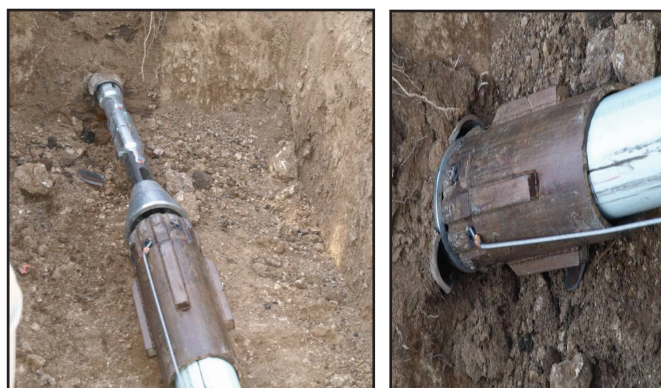
Figure 10. Pipe bursting a 4 inch (100mm) cast iron water main and upsizing to 6 inch (150mm) FPVCP.

The pipe bursting process also required the use of special equipment. The installation technique relies on a hydraulically actuated pulling device to fracture the existing pipe into fragments, push them into the surrounding soil, and simultaneously pull in the new product pipe. The process is also coupled with the hardware of the bursting 'train' and pipe attachment assembly. This special tooling connects to the pulling system of the equipment, assures that the existing pipe is sufficiently fractured and displaced, and finally expands the created annulus of the utility corridor to allow the trailing insertion of the new product pipe (see Figure 10). All of this equipment would need to be acquired as well, and this too would add to the initial cost of the program.
