OUTCOMES FROM A SEWER MAINTENANCE BACKLOG INVESTIGATION

Morné Pienaar

At the end of 2011 Phase Two of a six year maintenance backlog investigation on the sewerage network of Nelson Mandela Bay Municipality (NMBM) was concluded. The challenge was to conduct an accurate analysis of the infrastructure network in terms of Scope, Risk and Cost and to correctly allocate priorities for the systematic eradication of the maintenance backlog.

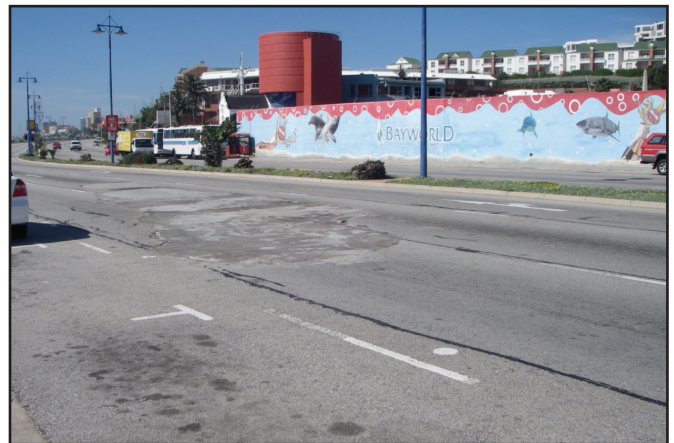
Sewer failure generally starts with poorly made joints or joints that become defective during service and start leaking. At high flows the effluent leaks from faulty joints saturating the surrounding soil. At low flows the groundwater infiltrates into the sewer and brings bedding material

Figure SEQ Figure * ARABIC 1: Signs of a leaking sewer pipe

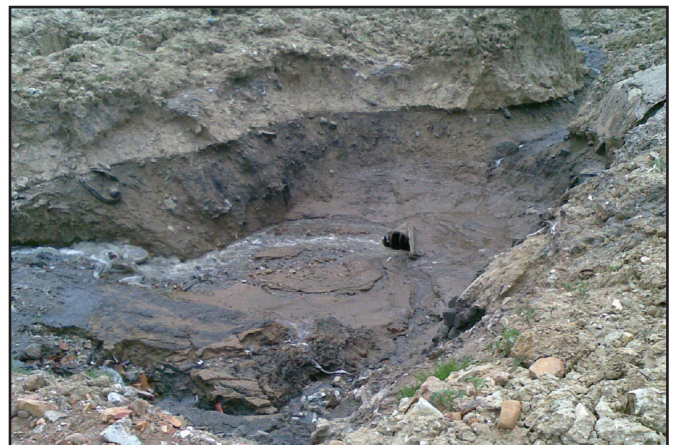
with it, thus reducing the support around the sewer, the formation of cavities and the structural collapse of pipes or the 'day lighting' of the cavities through to the surface as sinkholes.

Figure SEQ Figure * ARABIC 2: Erosion due to a collapsed sewer

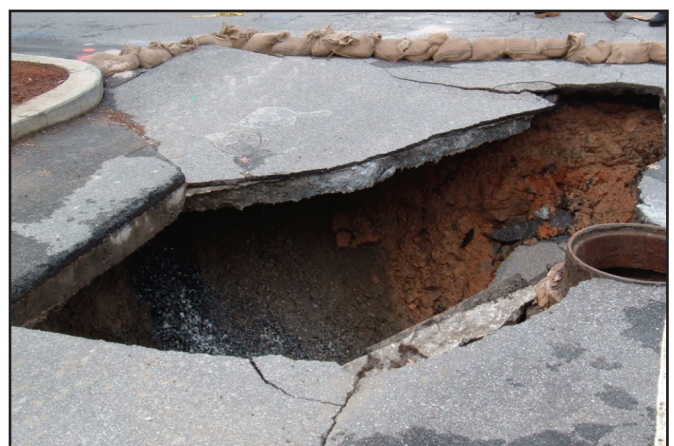
Figure SEQ Figure * ARABIC 3: 'Day lighting' of the cavities

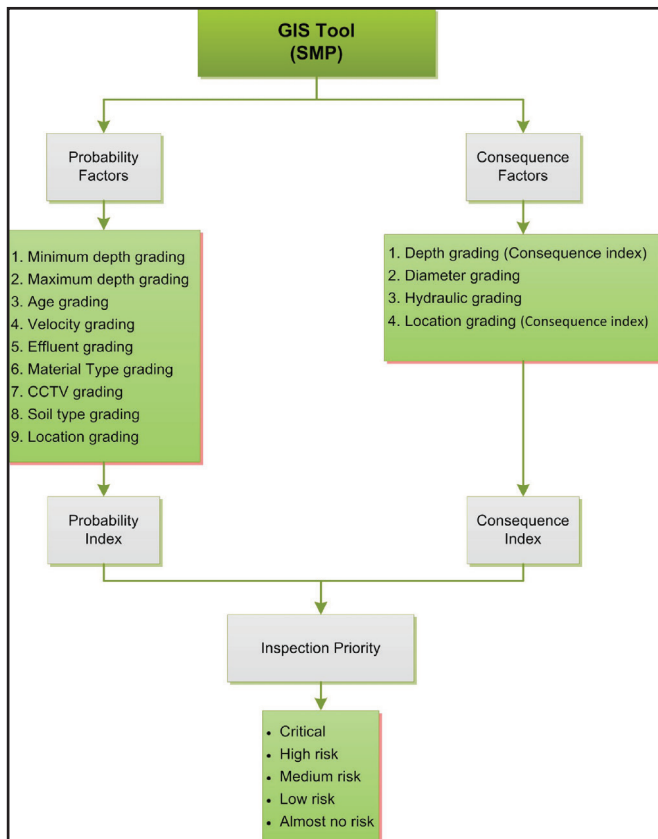
The SMP uses the characteristics of each sewer to predict the risk of sewer failure. It does this by calculating a Probability Index and a Consequence Index. These two indices are then plotted on a two dimensional matrix, and the point where the two indices meet on the matrix determines the sewers Inspection Priority. The Inspection Priorities are then grouped together to allocate the sewer into a risk category. This process is illustrated in the flow chart below.

Figure SEQ Figure * ARABIC 4: Methodology for Priority Identification

The Index of each sewer is calculated by grading the individual factors that affect the probability and the consequence of failure of each sewer. These factors are:

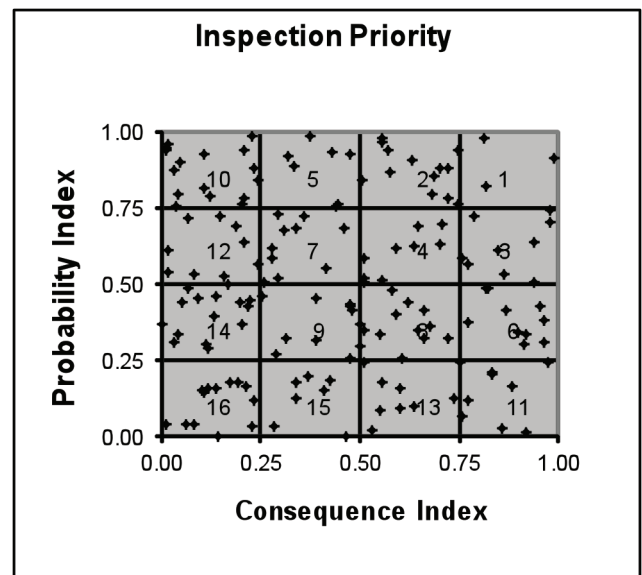
Obviously sewers with a very high probability of failure and catastrophic consequence of failure need to be inspected before any other sewer. Hence an Inspection Priority of 1 is the highest priority and an Inspection Priority of 16 is the lowest priority. This can be seen in a matrix format as shown below.

Figure SEQ Figure * ARABIC 5: Inspection Priority Matrix

Each dot in Figure 5 above represents a sewer between two manholes. It illustrates several advantages of using the matrix approach:

- The contribution of both probability and consequence of failure are shown
- Any patterns that have developed along a sewer can be seen
- By using different colours and symbols several sewers can be represented on a single figure
- The various sewers (and sections along them) can be compared on a relative basis.

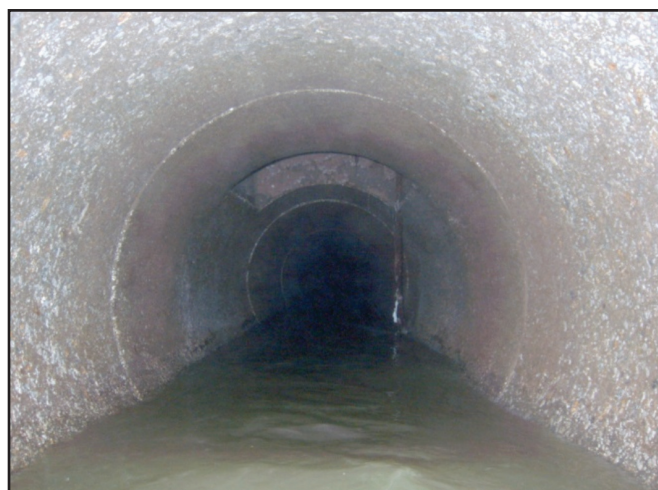
Figure SEQ Figure * ARABIC 6: CCTV Photo 1

At the end of the three year period, a total of 380 km was surveyed by means of CCTV. This represents approximately 53.7% of the original network identified for survey, and approximately 10% of the total length of the sewerage network in the NMBM (which equals approximately 3961km). Information gathered from the CCTV inspection provided a true reflection of the condition of pipes.

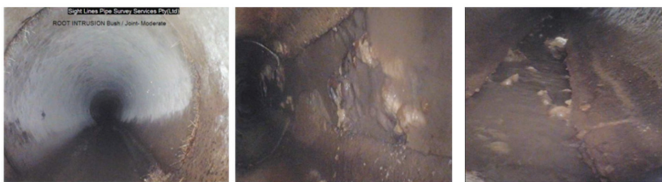
Pipe Condition

1. Severe pipe corrosion to pipe invert
2. Critical pipe corrosion at some changes (see CCTV pipe inspection reports)
3. Moderate obstruction
4. Moderate root intrusion
5. Minor fatty deposits

This pipe is in a poor condition and it is recommended that this pipe be replaced.
