## EMERGENCY STORMWATER UPGRADE FOR THE VIRGINIA AIRPORT AREA

Clint Chrystal<sup>(1)</sup>, Godfrey Vella<sup>(1)</sup>, Randeer Kasserchun<sup>(1)</sup>

<sup>(1)</sup>eThekweni Municipality, Durban, Republic of South Africa;  
Tel +2731 3117312  
E-mail clinton.chrystal@durban.gov.za

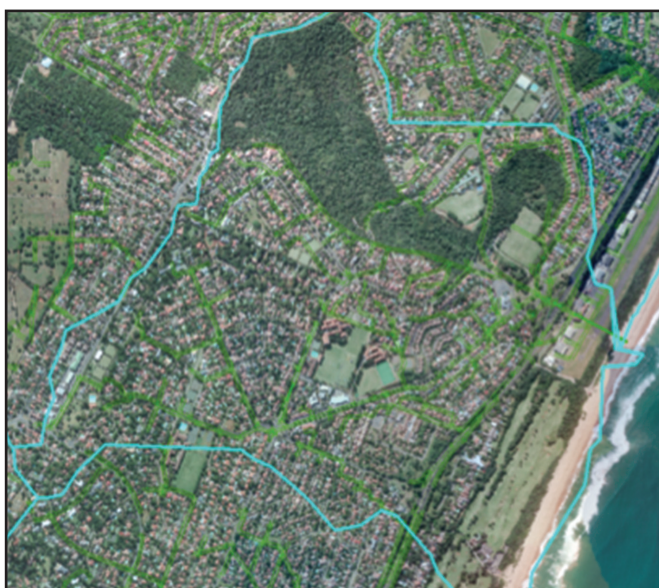
**Figure 1: Virginia airport catchment**

The Virginia Airport is located at the bottom of a large urban catchment. Sections of the catchment are characterised by steep slopes and high runoff coefficients due to the large percentage of impervious pavements (see Figure 1). Subsequently, the resulting stormwater runoff during flooding events produces volumes that exceed the current stormwater infrastructure capacity, which is designed for a one in ten year storm return interval. This results in excess stormwater runoff becoming overland flow as it cannot enter the stormwater network. The overland flow accumulates at a critical point, where three sub-catchments combine at Virginia Airport. The overland flow floods the adjoining road infrastructure and enters the Virginia Airport premises into the airport buildings.

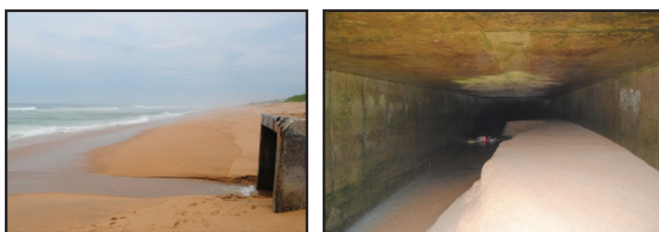
**Figure 2: Stormwater culvert blocked by the ingress of marine sediment**

The stormwater network infrastructure capacity is further hampered by the constriction of the culvert outlet, which provides the exit point for the stormwater runoff into the ocean. The culvert exit point is constricted by the ingress of marine sediment during tidal cycles. The marine sediment accumulates in the culvert, preventing the culvert from operating optimally (see Figure 2). Although periodic flushing occurs during smaller rainfall events, the initial choking effect compounds large flooding events.

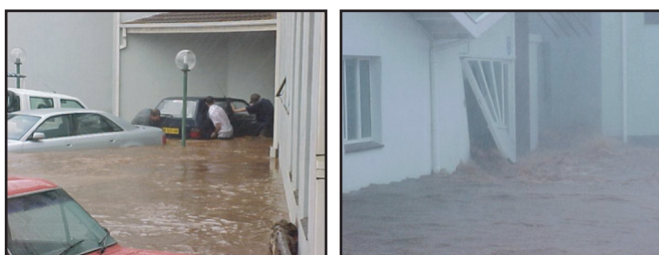
**Figure 3: Flood inundation in the parking lot, and flood water flowing through the airport building.**

The stormwater system functions satisfactory for most precipitation events with continual maintenance to clear out the marine sediment. However, when a large storm event occurs preceded by light rains to saturate the catchment depression storage, and the culvert is marginally blocked, causing flood damage to the lower catchment. Figure 3 illustrates recent storm flood inundation at the airport.

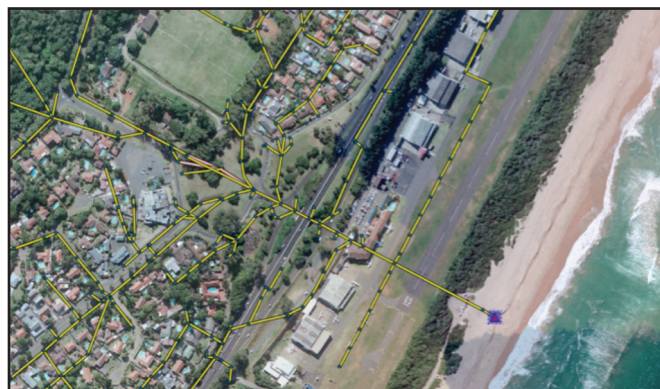
**Figure 4: Stormwater network in the lower lying section of the flooding section in SWMM.**

Calibration and validation of the model was done with the use of a water level and rainfall data. An acoustic doppler water surface height measuring instrument was installed early on in the project in a manhole located at the airport. Measurements of 5 to 15 minute intervals provided a large data set with which to calibrate the model using rainfall data from a gauge within the catchment. Validation was done in a similar manner routing subsequent rainfall data and comparing simulated runoff against measured stormwater runoff values. Validation was also done by comparing model simulation estimated overland flood volumes to water level depth reported in and around the airport building. Here, actual hind cast rainfall data for large storm events were simulated. Figure 4 presents the lower catchment system.

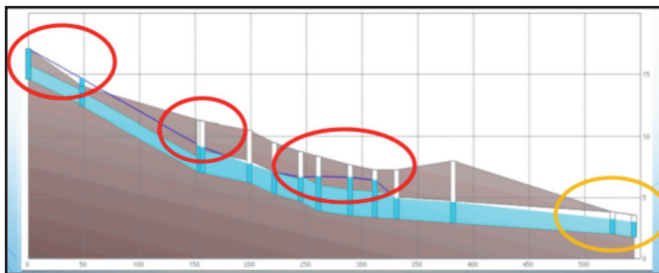
**Figure 5: Flooding at several nodes due to gradient changes and not marine sand ingress**

The modeling results indicated that a two pronged approach to mitigate flooding was required: (1) the extension of the culvert to prevent marine ingress blockages occurring and (2) the altering of runoff flow time characteristics. Initially it was thought that just extending the culvert would prevent flooding. The analysis showed however that the change in grade from steep to flat in the lower lying section of the catchment induced a hydraulic jump essentially in the three main 1200mm stormwater pipes before the airport. This change in grade resulted in a backup of water in the system that surcharged several manholes in the lower lying areas (see Figure 5). Even with an unblocked outfall, the system would flood the lower catchment. In a specific storm event the box culvert roof slab was lifted up by the pressure build up in the system, resulting in two

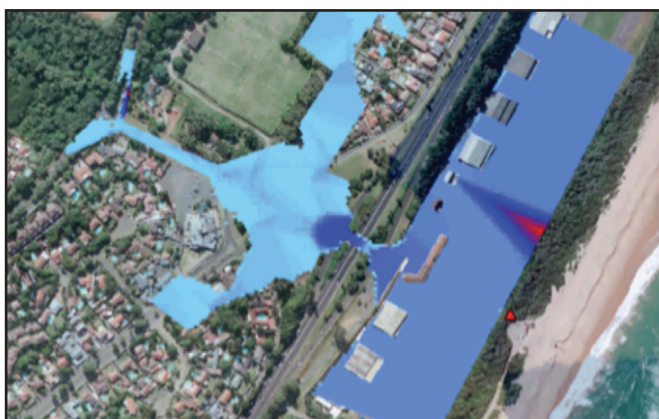
**Figure 6: Flooding simulation results from a quasi 2D model**

The use of a quasi inundation model was also used to check the overland flow results from the original model. Figure 6 illustrates the overland flow flooding event model. The models setup was based on a digital elevation model that incorporated 2m contour data and surveyed spot heights.

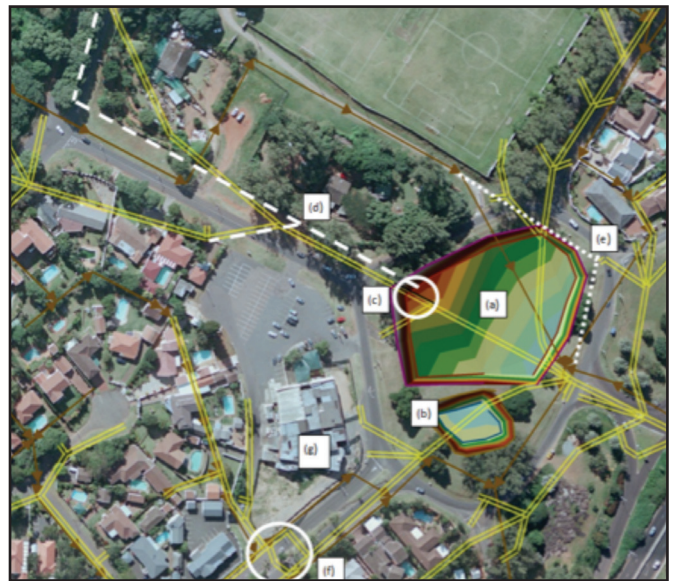
**Figure 7: Multi-lateral approach to mitigate flooding**

Part (a & b) involved the lowering of the ground level by approximately 1.5 to 2.5m and constructing 10 000 m<sup>3</sup> and 2 000 m<sup>3</sup> dry detention ponds. Limited by a high ground water table in depth, bank slopes were increased and a multi-cell embankment stabilised with grass used. An active sewer system was diverted around the new pond edge (e). Part (c) required some ingenuity as the pond was to remain dry and only function during high rainfall events. The new stormwater 1200mm stormwater pipe system placed in (d) flowed into a dual manhole chamber. During low flows, the stormwater would be re-directed in the chamber via a constriction point into the old existing stormwater system. The constriction was designed so that when flow rates exceeded a threshold, the excess flow would be diverted into the pond.

Alterations were also made to the overland flow (f) so as to divert the surface flow on the street to a small stormwater system that fed into (b). A new development of a shopping centre (g) required restrictions in the stormwater run-off and onsite storage to reduce additional stress on the system.

The combination of all these parts provided the optimum flood mitigation for the lower catchment. However, the key finding was that if the timing of the flows of the three main stormwater pipes could be changed, the surcharging manholes would be significantly reduced. In other words, the main objective of the detention pond is to retain the central stormwater pipe discharge in the detention pond, whilst the northern and southern runoff volumes pass through. The stored volume then enters the existing system after their peaks have passed through.

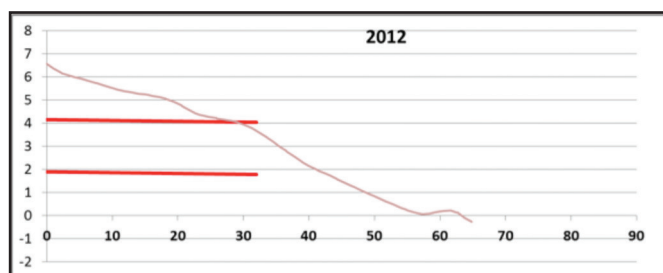
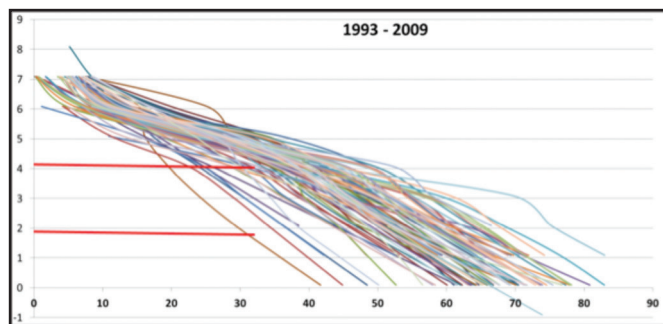
**Figure 8: Culvert extension length determination – looking at a snap shot in 2012 and then looking at a combination of data sets collated from 1993 to 2009.**

The design of the culvert extension highlighted the success of an extensive monitoring program implemented by the local authorities. Figure 8 presents surveys measured of the beach profile over several years. If one only had a snap shot of the beach width and profile in 2012, a culvert extension of approximately 20m seawards would appear satisfactory. Fortunately, profiles for several years back were recorded that indicated the necessity of a 48m extension to exceed the 90th percentile of maintaining an open culvert. If the beach profile survey had been done after the project had commenced, the culvert would have been designed too short, and once the beach profiles returned to normal, the culvert would have been blocked again.

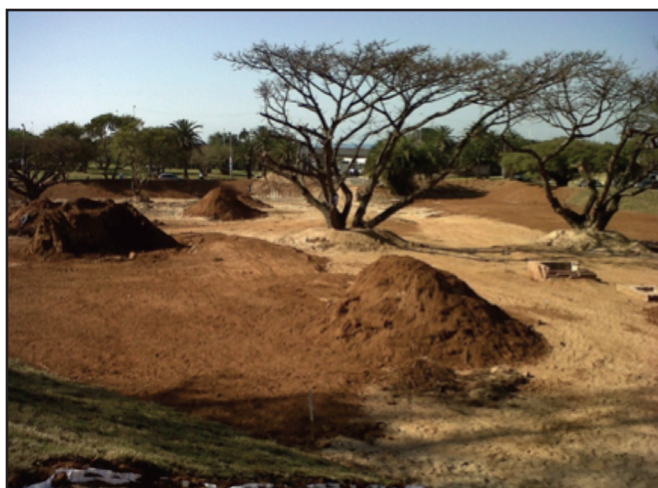
**Figure 9: Construction around several old fig trees resulted in the successful replanting of them to the communities delight.**

The community also played a large role in the construction approach of the detention pond. Initially the design incorporated an open air theatre that could accommodate small events such as Christmas Carols. This was turned down by the community, but a request was made to save some of the old fig trees and maintain a green park appearance. In order to achieve this, the design team worked with the contractor and horticulturist to 'save' the fig trees. By lifting the trees up with an excavator and lowering the ground level below them, before replanting, the fig trees were kept in place, at 3m below original level. The trees took several weeks to respond, but have successfully grown again (see Figure 9 to see the 2 largest ones in the middle of the construction site).

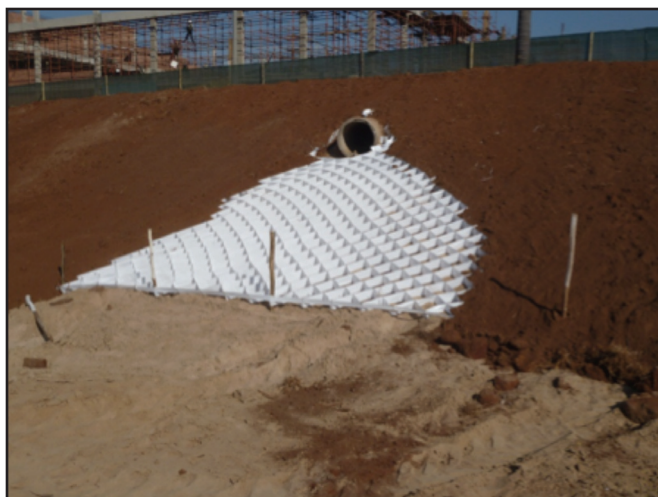
**Figure 10: The use of multi-cell planted with grass allowed steeper gradients to increase capacity and the natural appearance of the pond. The multi-cell was also used with concrete to build open channels, linking low flows through the pond from adjacent storm-water manholes to the outlet of the pond.**

Due to the limitations of sizing the pond, between the road circle and high water table, berms were created on the lower end of the pond. The ground level has a natural slope towards the east, and so a semi-circle berm was built on the lower end top embankment to increase the capacity of the pond. Figure 10 illustrates the use of a multi cell that was planted with grass to increase side slopes for an increased capacity, while maintaining a natural appearance as oppose to the use of retaining blocks. The berms were however limited in height so as to allow the public to see into the pond, whether in a vehicle or walking past. This was a safety concern that was incorporated into the design.

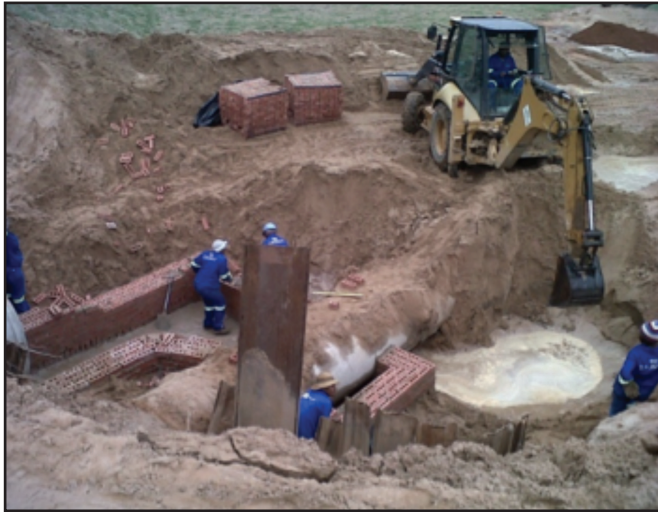
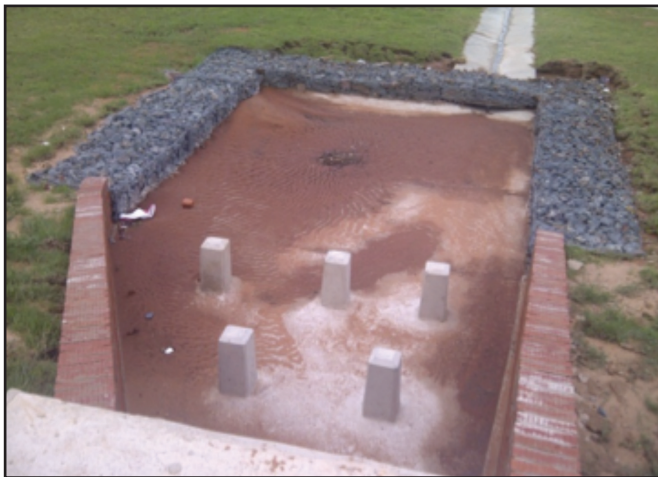
**Figure 11: Construction of the control point diverting flows above 1m<sup>3</sup>/s threshold from the chamber into the detention pond.**

The construction of the control point for the detention pond required the construction of a large chamber to incorporate the control constriction opening and link into the existing stormwater system. The high ground water table and higher than average rainfall made construction troublesome. The chamber needed to withstand large flows and high velocities impacting on the wall. Normal dry flows were redirected through the constriction opening, but once flow exceeded a threshold value of approximately  $1\text{m}^3/\text{s}$ , the chamber is forced to surcharge out an opening to the detention pond. Due to the high velocities exiting the chamber into the detention pond, an extensive break down system was built (see Figure 11).

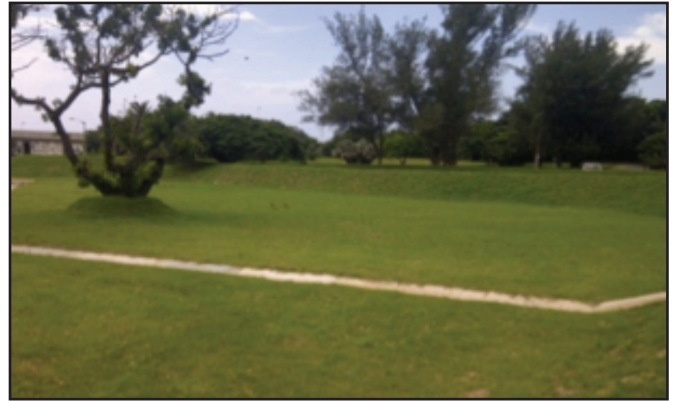
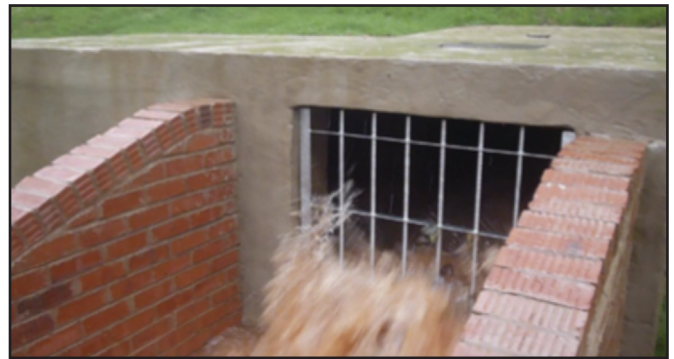
**Figure 12: Post construction of the Virginia dry detention pond and the control chamber in action.**

In order for the detention pond project to be aesthetically pleasing to the community and enhance the 'green zone' of the area, the contract included planting of grass and approximately 20 new fig trees along the streets. Figure 12 presents the project just after competition with the control chamber in action.
