PAPER 15

H₂S BIOGENIC CORROSION: WHY USING CALCIUM ALUMINATE CONCRETE AND MORTARS TO REHABILITATE CORRODED SEWER INFRASTRUCTURES

François Saucier¹ & Tendayi Kaitano²

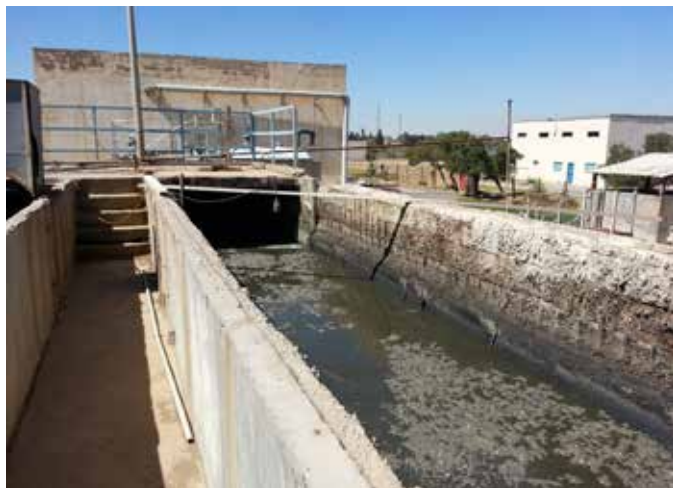
Figure 2 – Typical appearance of severe H_2S biogenic corrosion damages in the entry channel of sewage treatment plant: around 50 to 70 mm of concrete has been lost with rebars totally corroded away in some parts.

Figure 2 is showing the typical appearance of a concrete wall in a sewage treatment plant (STP) being severely damaged by H_2S biogenic corrosion.

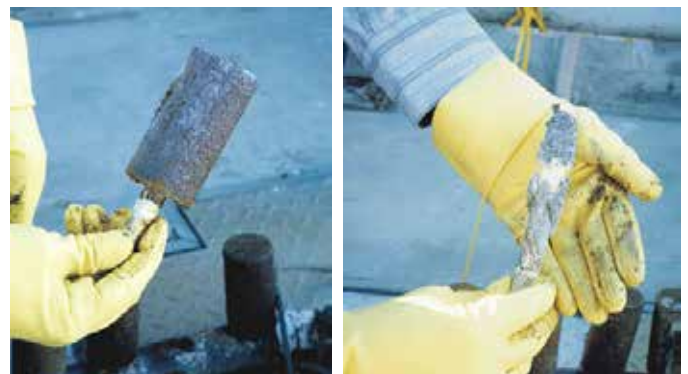
Figure 3: In situ specimens exposed for two years in the grit chamber of Monterey Wastewater Treatment Plant. Left: 100% CAC mortar. Right: OPC mortar

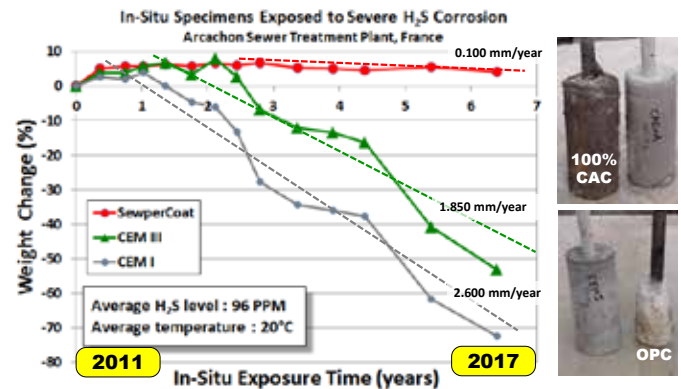
Figure 4: Mass loss and corrosion rates measured on specimens exposed in a STP in France

construction. One part of this program involved monitoring different type of concrete specimens - including some CAC based specimens - exposed to severe H₂S biogenic corrosion in a sewage treatment plant in Arcachon, in southern part of France. The results after 4 years of exposure were published by Herisson et al. 2017. The Figure 4 is showing the corrosion observed on OPC and CAC specimens after 6 years of exposure (not published yet).

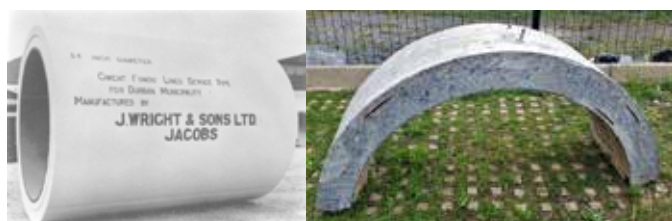
Figure 6: Precast concrete pipes with an internal lining of Ciment Fondu® mortar installed at Durban Municipality around 1955: left, at time of manufacturing in 1955; right, segment extracted in April 2018 in Point Road area with the Ciment Fondu® mortar lining still present.

Field performance of real structures is showing the same CAC resistance to H₂S corrosion as proven in academic studies. A first impressive result comes from eThekweni Municipality in South Africa. Around 1955, more than 60 years ago, several kilometres of sewer was built with 1.35 m diameter precast concrete pipes. As shown in Figure 6a, these pipes were made with an internal protection made of a "one inch" (2.54 mm) Ciment Fondu® mortar.

In 2018, some length of this sewer has reached the end of its service life and a new sewer is being built in the Point Road area to replace it. This gave the opportunity to dig-out some 60 years old pipes in April 2018 to perform a diagnosis. At time of writing this paper, the results are not yet available but Figure 6b is showing that the Ciment Fondu® lining is still in place after all those years. Further data will be made available in the near future.
