PAPER 5

Partial Reconstruction and Lengthening of a Continuous Post-tensioned Concrete Bridge Deck: Case Study of Emergency Rehabilitation of the Seaward Road Bridge

Peter Fenton, Jitesh Harripershad, Luke Reid

eThekweni Municipality, Roads Provision Department:
Structures Branch

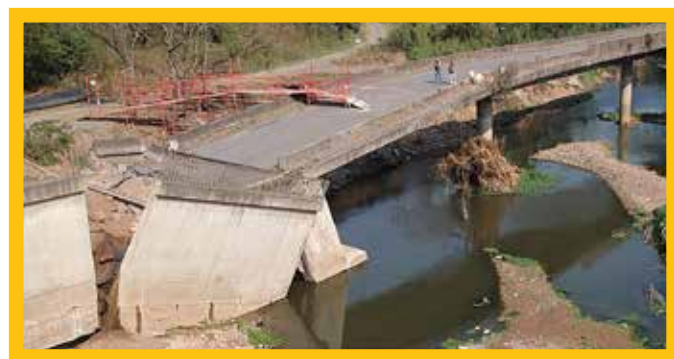
FIGURE 1: The collapsed eastern abutment and end span of the Seaward Road bridge over the Umhlatuzana River

The bridge crosses a complex curve in the river, which was originally intended to be canalised. The flooding first eroded the river's eastern embankment immediately upstream of the bridge, redirecting the flow directly at the face of the eastern abutment, where the piles were exposed, and the abutment wingwall dislodged. The saturated abutment fill pushed the precast piles out of position, then sheared them off. Without the piles, the abutment collapsed. The remainder of the deck was not strong enough to perform without the abutment's support, and the deck stresses were transmitted far beyond the end span, straining the prestress and reinforcing steel beyond serviceability and cracking the concrete. The deck was twisted over sideways on its bearings and the end span slumped down (Figure 1).

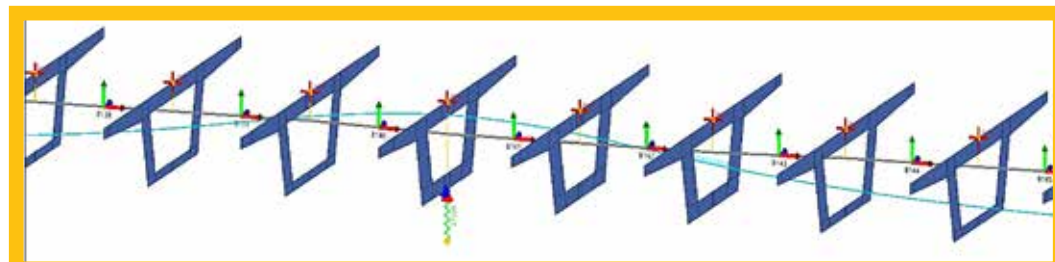
FIGURE 3: Typical extract from RM Bridge FEM Model – the entire bridge had to be modelled due to the increase in jack (end) span length and accurately account for time-related effects on the structure

Careful modelling of the various stages of the bridge's construction, lifespan, demolition, reconstruction and future lifespan was done using advanced Bentley RM-Bridge software (Figure 3). The long-term prestress losses in the 40 year old portion of the deck are substantially complete, while the losses would only just be starting for the new portion. The designers needed to be confident that despite the future variability in prestress losses over time, the residual force at the prestress coupler would remain balanced and the connection would not be overstressed, which could have extremely serious consequences. The prestress in the new portion of the bridge is thus 64% of ultimate tensile strength, not 70% as per the as-built design.

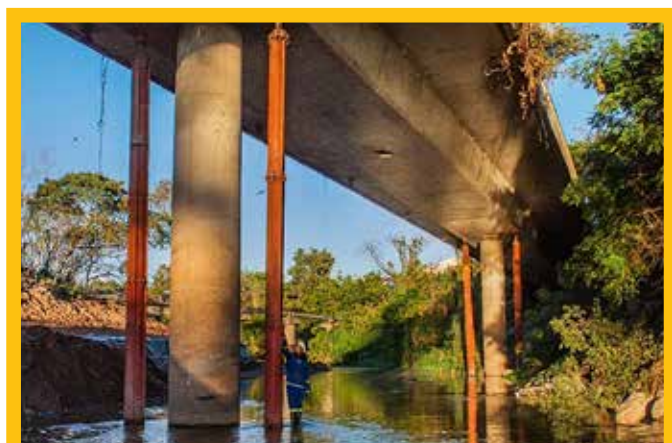
FIGURE 5: The remainder of the existing structure had negligible stability and needed to be carefully propped until construction was complete

The collapsed portion of bridge deck needed to be removed without causing the remaining portion to collapse and become unsalvageable or pose a safety risk for workers. Temporary stability was achieved with the urgent installation of ultra-heavy-duty 1 000kN props (Figure 5) on either side of each pier. The props had to be monitored and adjusted throughout the demolition and reconstruction phases, to balance the torsional forces

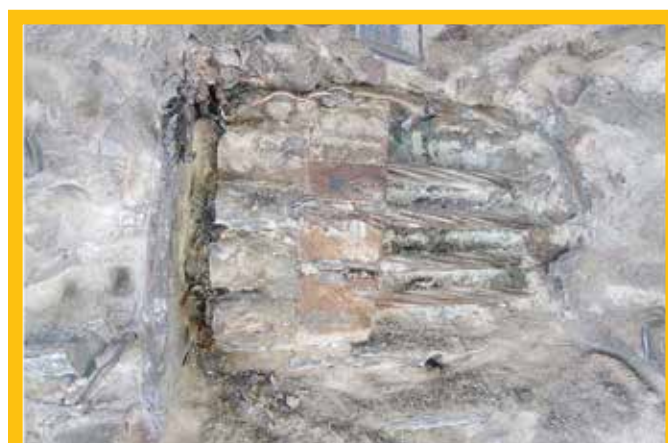
FIGURE 6: Buried coupler being carefully exposed with sharpened chisels and no power tools

The latest South African specifications state that “Water jet removal of concrete is preferred wherever possible” (Committee of Transport Officials 2020). However, on making enquiries it was found that it is still true that “techniques for cutting the concrete and exposing tendons are highly specialised and expensive. Water jetting with a grit additive will cut the prestressing tendons. To avoid damage to the steel, water jetting without an abrasive additive must be specified.” (Telford, 1995). Due to high cost and lack of suitable options, couplers were instead carefully exposed by hand, with sharpened chisels to minimise any microcracking (Figure 6). The existing steel reinforcement was also treated with care, so new rebar could be spliced onto it.

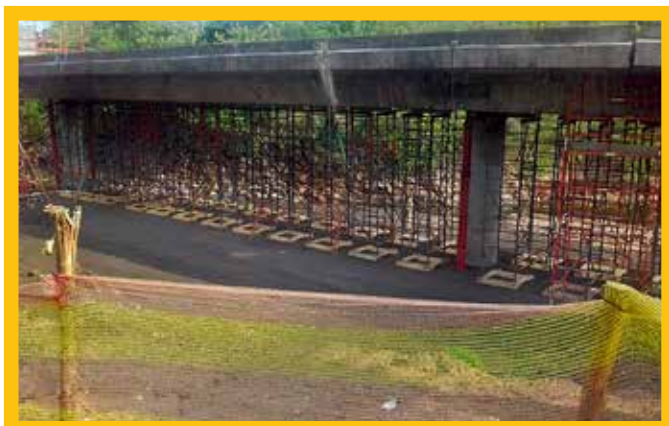
FIGURE 7: Sacrificial props maintained stability until demolition

The portion to be demolished was stabilised with lightweight, sacrificial falsework props (Figure 7), which needed to be accurately designed. If the props were too strong, they would be a large, unnecessarily wasteful expense, and might delay the collapse and cause it to happen in an unpredictable, dangerous way. If the props were too weak, the deck could collapse prematurely, in a similarly dangerous, unpredictable way.

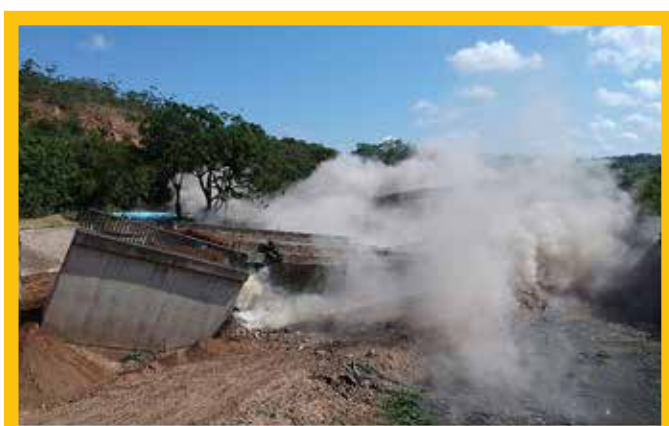
FIGURE 8: The demolition process was designed to minimise environmental effects

With the deck wrapped in geofabric to prevent flying debris, a carefully designed sequence of closely timed blasts created a safe, predictable collapse (Figure 8). The blasts were also designed to ensure that their vibrations would not destabilise the remaining portion of the deck, or affect nearby railway lines.

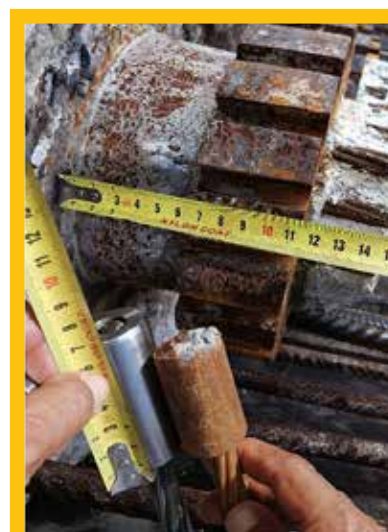
FIGURE 9: Comparing the existing couplers with the closest available match on the contemporary market

A major setback was discovered when the prestress couplers were exposed: the VSL fittings from 1979 are not compatible with the prestress systems available today. Extensive enquiries were made among South African prestress suppliers, but only one of them, OVM, could supply coupling components for 12.9mm strand. Unfortunately, the swage thickenings supplied by OVM would still not fit into the grooves of the old couplers (Figure 9). The only option was to modify the modern swages to fit and test the results in a laboratory empirically.

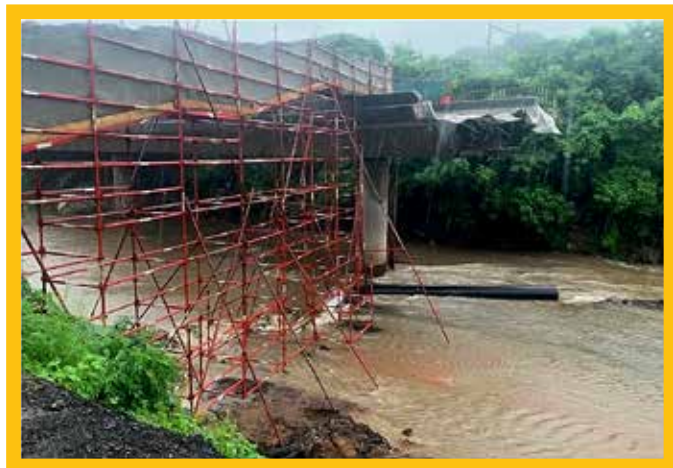
FIGURE 10: Temporary supports had to withstand repeated flooding

During construction the site suffered significant additional flooding (Figure 10). The irregular bend and susceptibility to flooding of the Umhlatuzana river make it hard to predict its behaviour, and ongoing development upstream will produce stronger flows in the future. To safeguard the City's asset and public safety, an exceptionally robust new abutment and wingwall were designed. A mass abutment with encapsulated fill material provides the stability to withstand high loads and is protected by very long wingwalls. It sits atop a large, monolithic, three-tier pile cap, which required careful design, detailing and construction monitoring to ensure no thermal or shrinkage cracks occurred in the complex arrangement. The 39 piles of 500mm diameter were installed with a specialised 'overburden drilling eccentric' method, otherwise known as an 'Odex pile' or 'Rota-pile'. This uses 'down the hole' percussion impacting to penetrate boulders, and pull down permanent casings, which prevent river scour effects. Extensive gabion protection works were added upstream on the east bank to prevent a reoccurrence of the flood-related erosion of the riverbank that had initiated the collapse of the original abutment.

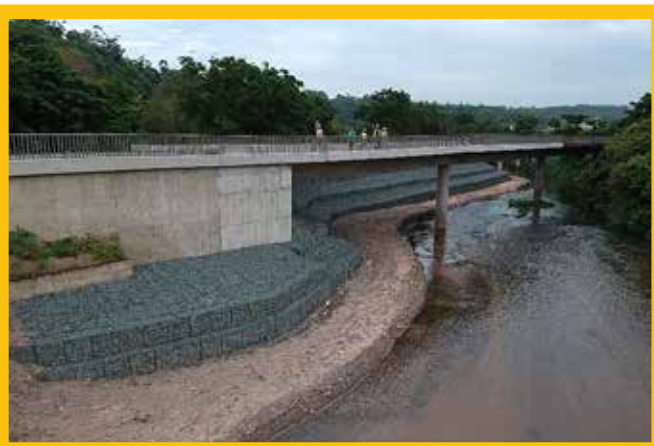
FIGURE 11: The new abutment is unusually heavy and sits behind extensive protection works
