THE STRUCTURAL REHABILITATION OF THE FISH WATER FLATS WASTEWATER TREATMENT WORKS IN NELSON MANDELA BAY MUNICIPALITY

Venancio Andrade da Silva¹ and Ignatius Du Preez van Renen¹

¹Afri-Coast Engineers, Port Elizabeth, Republic of South Africa;
Tel: +2741 5058000; Fax: +2741 5853437;
e-mail: venanceda@afriacoast.com

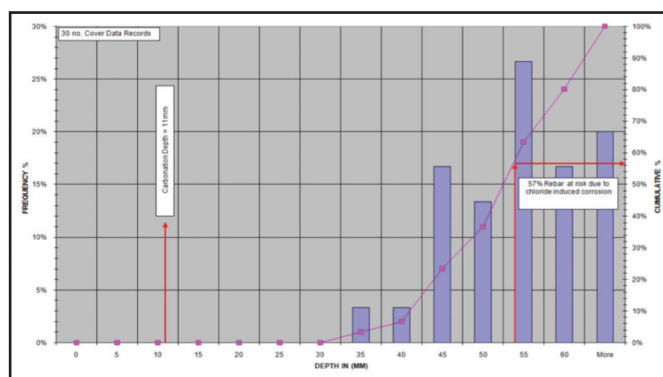
Figure 6: Typical statistical presentation of reinforcing steel cover survey overlaid with carbonation and chloride risk of corrosion.
