PAPER 17

FLOODING IN LADYSMITH, PROBLEMS AND SOLUTIONS.

Dr. Nezar A. Eldidy, Pr.Eng.
Sobek (PTY) Ltd

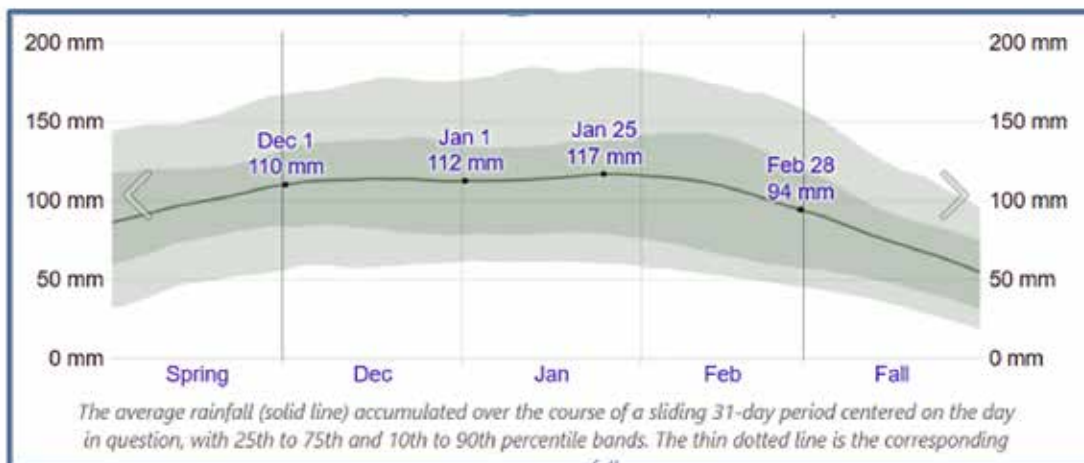
FIGURE 3: Max-Min values of recorded monthly rain intensity in Ladysmith – source: weather-atlas.com

The analysis of the precipitation during flood events at which such period shows the following:

- The Maximum Daily Precipitation (MDP) occurring at every 25-year period stands at 95mm.
- The Maximum Hourly Precipitation (MHP) is about 40mm with a return period of less than 4 years.
